PROVIDENCE RIVER BASIN  
LINCOLN, RHODE ISLAND

OLNEY POND DAM  
RI 01702

PHASE I INSPECTION REPORT  
NATIONAL DAM INSPECTION PROGRAM

OCTOBER, 1979 85 6 28 110

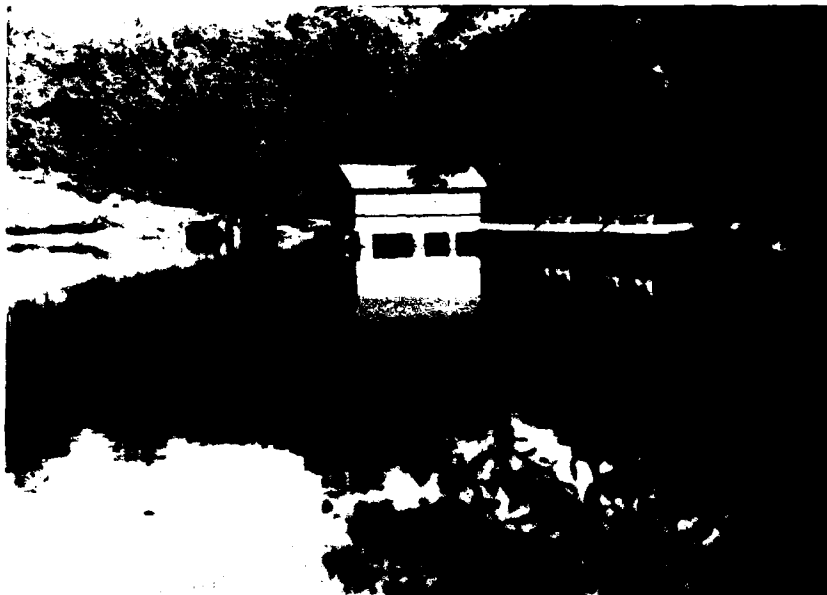
Overview of spillway entrance, gate house and upstream face of dam from right abutment.

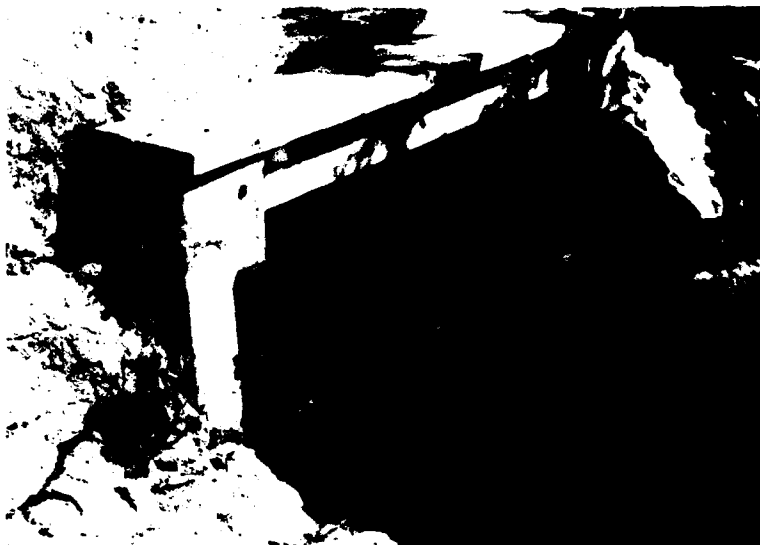
a. Approach Channel	None
General Condition	Entrance to spillway is obstructed by a closely spaced trash rack.
Loose Rock Overhanging Channel	N.A.
Trees Overhanging Channel	N.A.
Floor of Approach Channel	N.A.
b. Weir and Training Walls	Tunnel sluiceway with rectangular entrance.
General Condition of Concrete	Masonry - Good
Rust or Staining	None
Spalling	None
Any Visible Reinforcing	None
Any Seepage or Efflorescence	None
Drain Holes	None
c. Discharge Channel	Natural Channel
General Condition	Satisfactory
Loose Rock Overhanging Channel	None
Trees Overhanging Channel	Heavily wooded area
Floor of Channel	Natural Rock Channel
Other Obstructions	None

7. Spillway entrance with trash rack.
